Subject: Tree Evaluation Report

**EVALUATION OF TREES
AT
THE ROSE HILL HOUSE**

**90XX 126TH AVENUE NE
KIRKLAND, WA 98033**

January 24, 2008

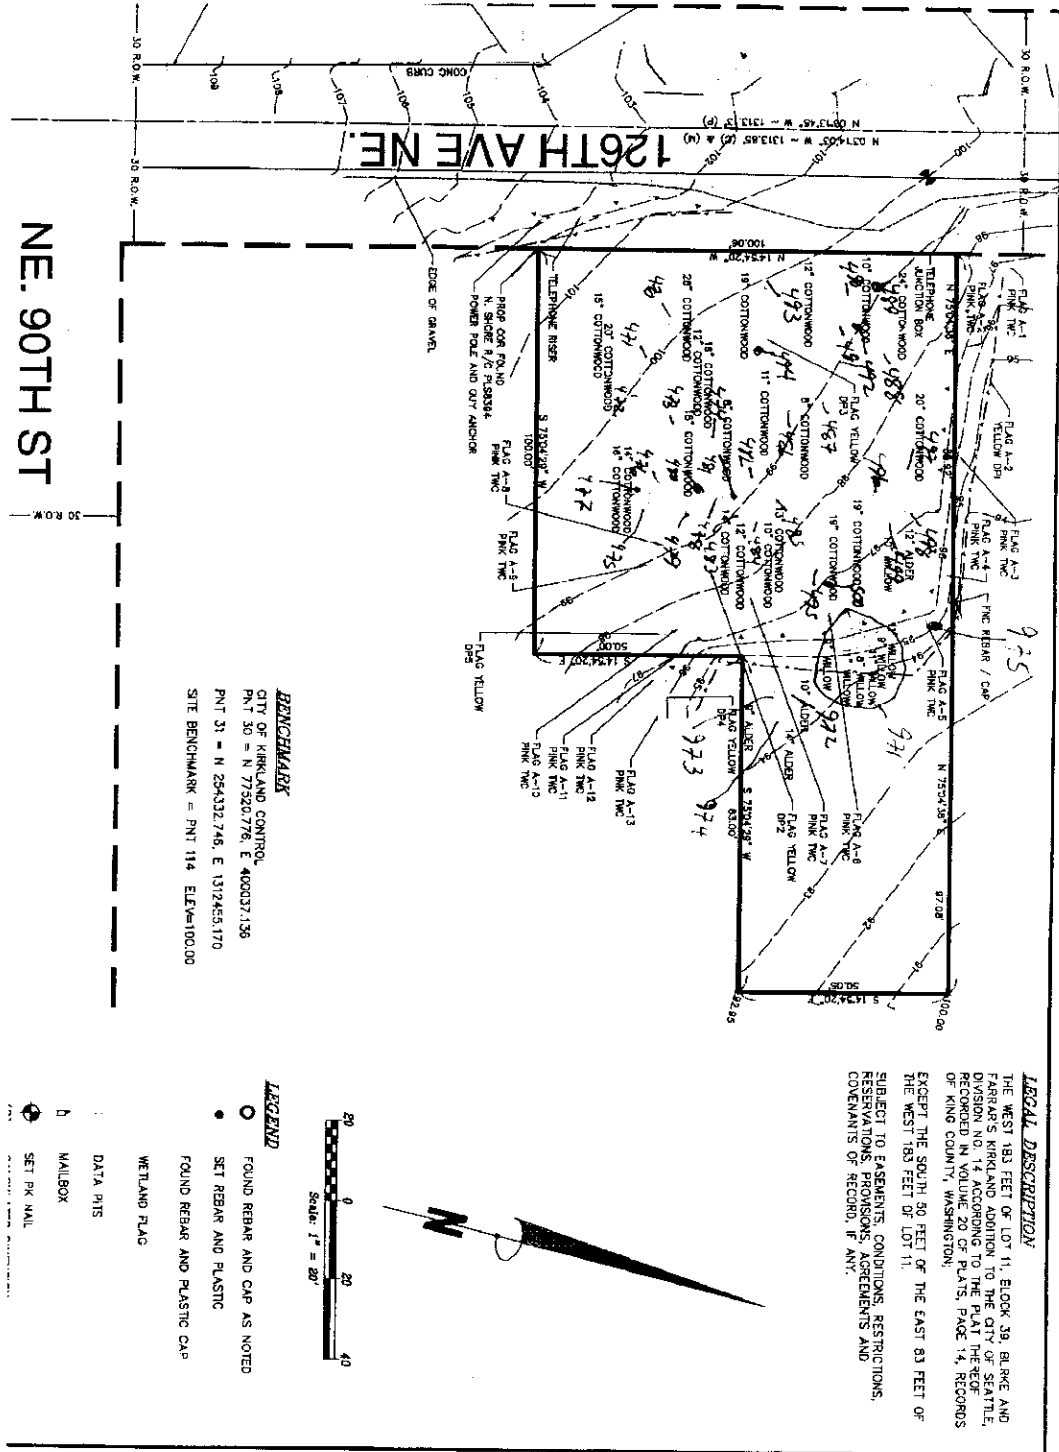
ATTACHMENT 1 - SITE PLAN

-	484	BCW/PR	10.0"	1.0	6'	6'	6'	6'	6'	50%	Maj. Asym.	ab/ase	Average	leans NE	NAD	-		significant	Good	Viability	Potential to retain with Tree Protection Measures

-	485	BCW/PR	13.5"	2.0	12'	12'	12'	12'	12'	50%	Min. Asym.	ab/ase	Average	Typical	NAD	-		significant	Good	Viability	Potential to retain with Tree Protection Measures

-	486	BCW/PR	11.4"	1.0	12'	12'	12'	12'	12'	40%	Gen. sym.	ab/ase	Average	Typical	NAD	-		significant	Good	Viability	Potential to retain with Tree Protection Measures

-	487	BCW/PR	8.1"	1.0	6'	6'	6'	6'	6'	40%	Gen. sym.	ab/ase	Average	Typical	NAD	-		significant	Good	Viability	Potential to retain with Tree Protection Measures

-	488	BCW/PR	20.6"	4.0	22'	22'	22'	22'	22'	65%	Gen. sym.	ab/ase	Healthy	Typical	NAD	-		significant	Very good	Viability	Potential to retain with Tree Protection Measures

-	489	BCW/PR	5.5"	0.5	5'	5'	5'	5'	5'	20%	Maj. Asym.	PS/PSSE	Suppressed	leans NW	NAD	-		not significant	Fair	Viability	Potential to retain with Tree Protection Measures

-	490	BCW/PR	9.1"	1.0	12'	12'	12'	12'	12'	60%	Min. Asym.	ab/ase	Healthy	leans NW	NAD	-		significant	Good	Viability	Potential to retain with Tree Protection Measures

-	491	BCW/PR	10.8"	1.0	12'	12'	12'	12'	12'	70%	Gen. sym.	ab/ase	Healthy	Typical	NAD	-		significant	Very good	Viability	Potential to retain with Tree Protection Measures

-	492	BCW/PR	6.3"	1.0	5'	5'	5'	5'	5'	30%	Maj. Asym.	PS/PSSE	Suppressed	leans NW	NAD	-		significant	Fair	Viability	Potential to retain with Tree Protection Measures

-	497	BCW/PR	20.0"	4.0	22'	to prop. Me	22'	22'	22'	45%	Min. Asym.	ab/ase	Healthy	leans north fork at 1' w/included bark	NAD	-	Trunk diameters are 11.3 & 5.5 inches = single trunk of 12.8 inches. Dead branches and broken and hanging branches in canopy.	significant	Very good	Viability	Potential to retain with Tree Protection Measures

-	498	RA/VA	12.0"	0.5	n/a	n/a	n/a	n/a	n/a	30%	Maj. Asym.	PS/PSSE	Broken Out	-	NAD	-		significant	Dying	Non-viable	Remove with Tree Protection Measures
-	499	PW/VI	7.7"	1.0	12'	12'	12'	12'	12'	25%	Maj. Asym.	PS/PSSE	Weak	leans east	NAD	-	lots of epicormic growth on the lower trunk.	significant	Fair	Viability	Potential to retain with Tree Protection Measures

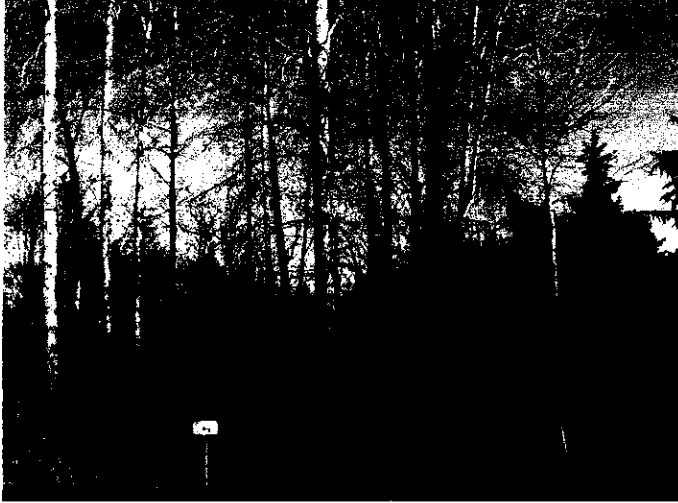
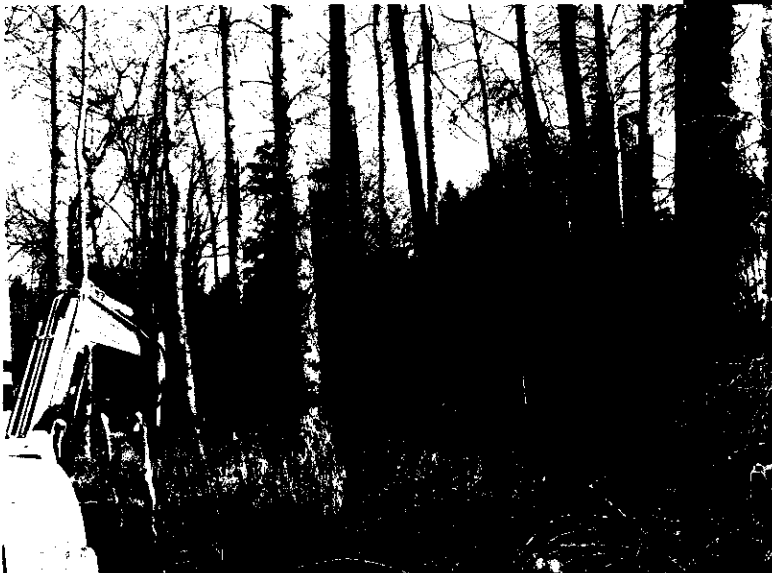
ATTACHMENT 4 - PHOTOS

Views from 126th Avenue NE looking east, north east, and east--taken 1-24-08
